Hydrology and Hydraulics Report
Haines Highway Milepost 3.5 to 25.3
Study for Preliminary Engineering Report
ADOT&PF Project No. 68606 / SHAK-095-6(28)

Prepared by:
Inter-Fluve, Inc.
1020 Wasco Street, Suite I
Hood River, OR 97031
541.386.9003
www.interfluve.com
October 3, 2006

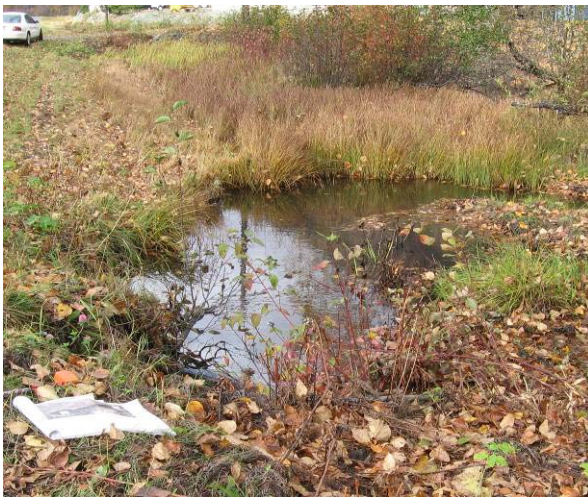
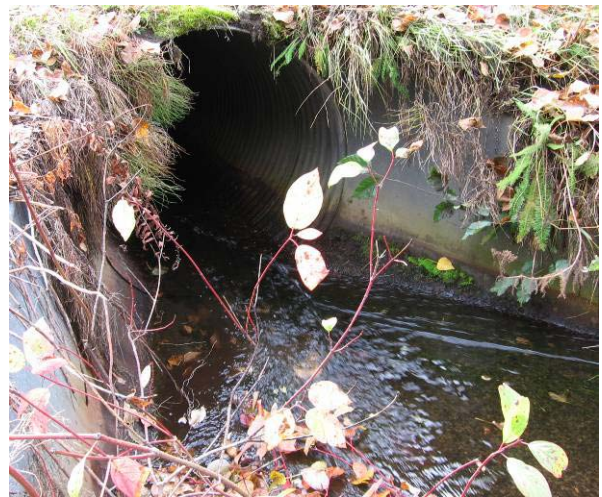
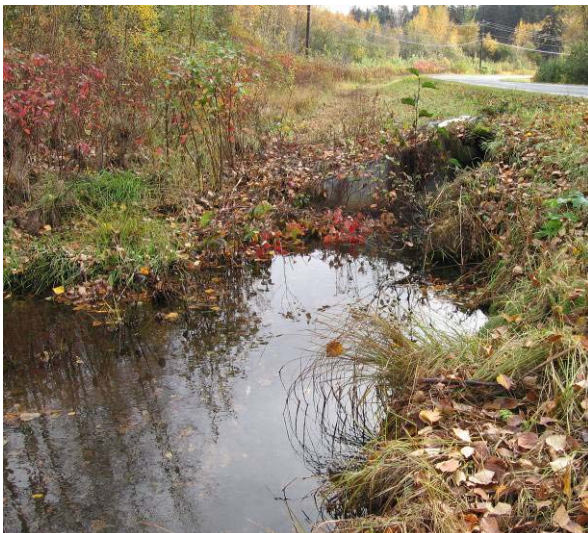
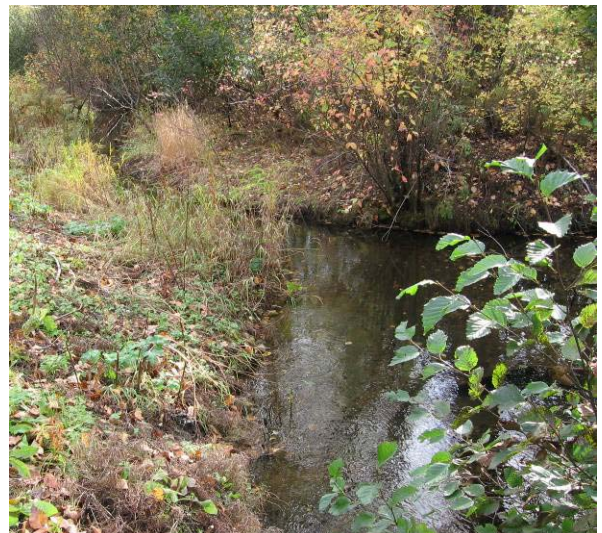
Description: Based on hand measurements, upstream of the culvert the stream is a 3-6' wide, E type channel with a substrate of mixed sand and organics. There is a small pool at the culvert inlet. Downstream of the culvert the stream winds along the toe of the road fill slope back to station 234+50. The upstream half of this 1050' section is also an E type channel 3-6' wide with a sandy/organic substrate. Stream banks are grassy, woody debris is present and alder often overhangs the stream. The lower ½ of this section is influenced by the river backwater, wider (6-10'), more open and 6-18" deep. Substrate is silt, sand, fine gravels and organic matter. Aquatic weeds shape the stream meander and banks are grassy or vegetated with alder and willow.

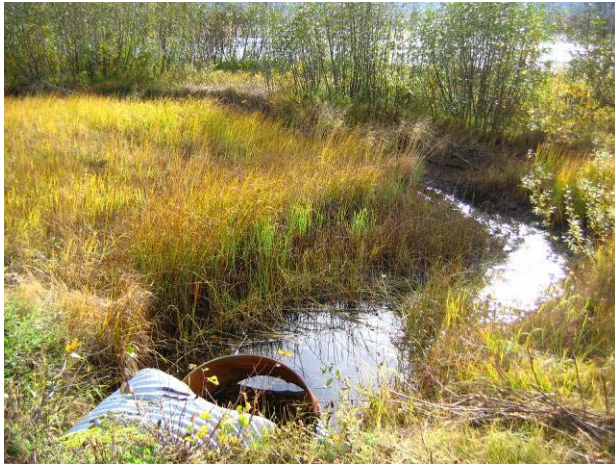
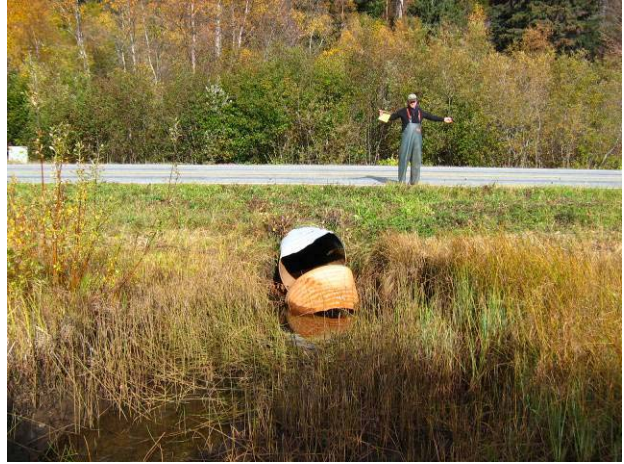
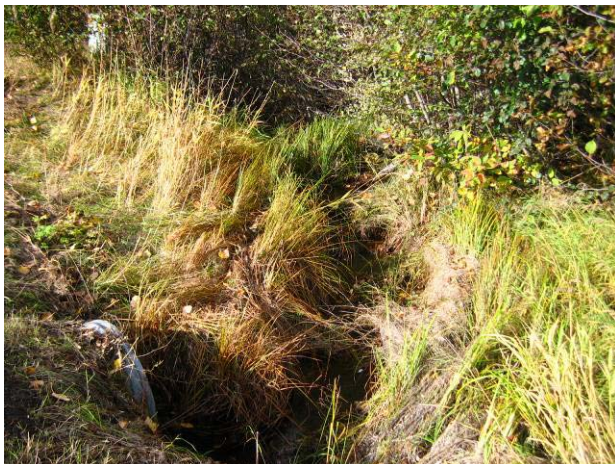
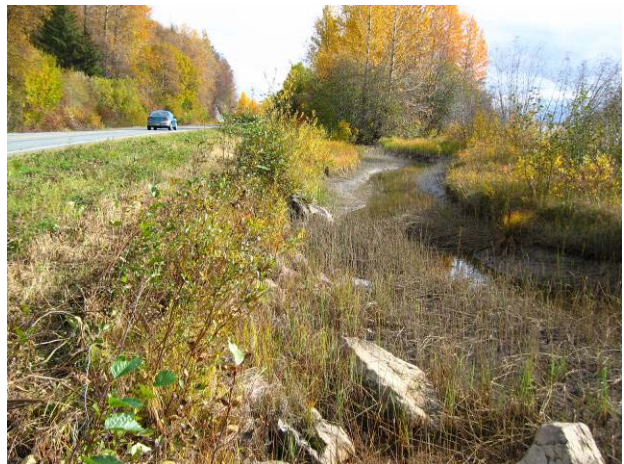
Description: Based on hand measurements, upstream of the culvert the complex channel of the stream meanders among alder roots and downfall. The stream is 1-3' wide with a substrate of gravel and organics. Depth is 6-8" and overhanging cover is dense. The downstream end of the culvert is perched 3-4" and unraveled. The stream meanders along the road back to station 339+75 before entering the Chilkat River. The river backwaters the stream and deposits silt over the gravel bed. The stream is 4-6' wide and 3-4" deep. It lies in an old flood channel of the river. Stream banks are grass covered.

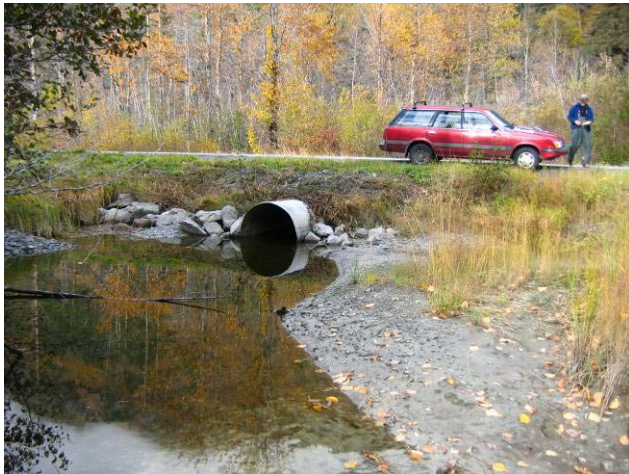
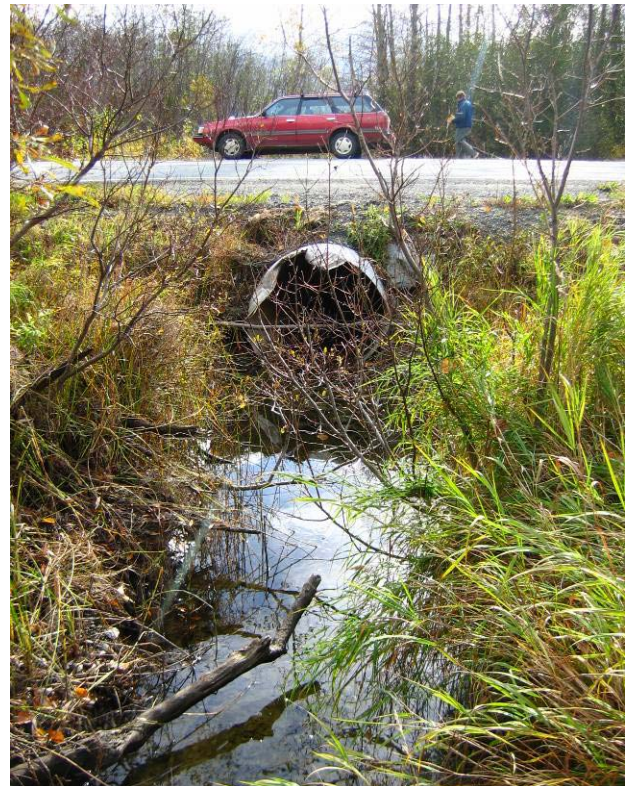
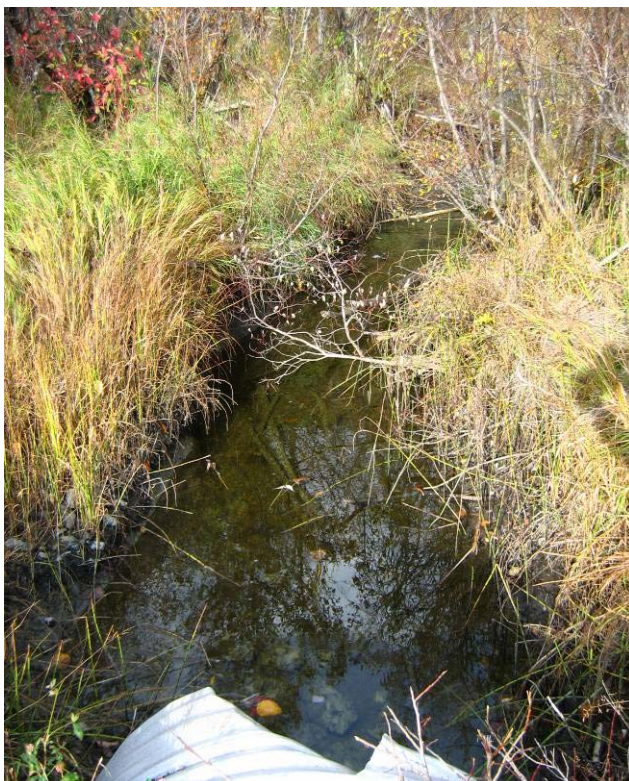
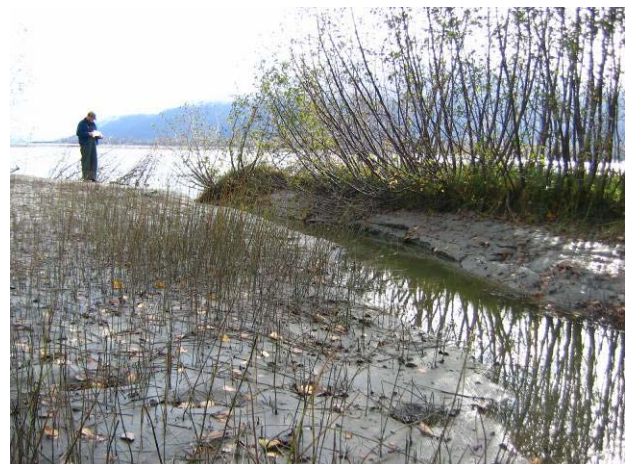
Description: The culvert appears to be fairly recently replaced. Based on hand measurements, upstream of the culvert the stream is a 1-2' wide E type channel with a fine silt and gravel substrate. The stream drains a swamp fed by numerous springs along the toe of the mountain. The culvert outlet empties into a short section of gravel bottomed stream with a width of 2-3' and grassy banks. The stream then turns into a 3-6' wide backwatered slough with a silt substrate. Springs feed this section of the stream.

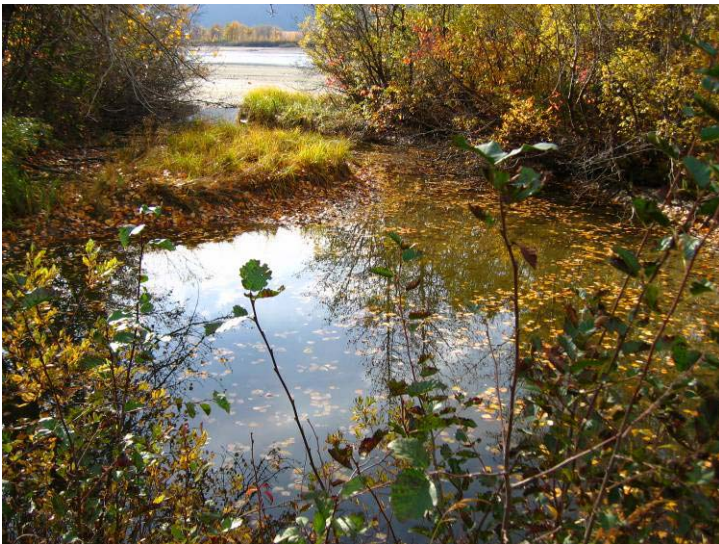
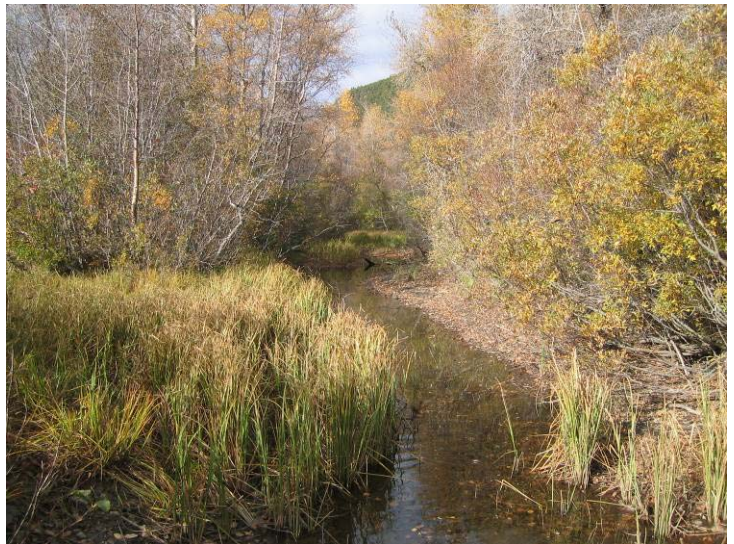
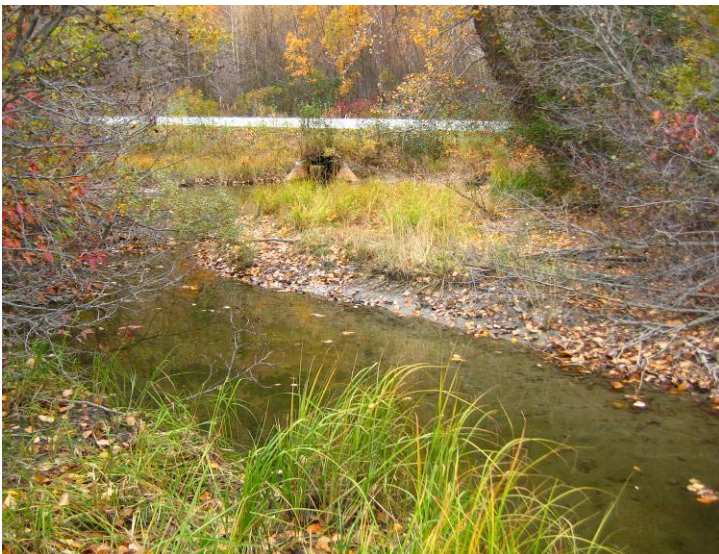
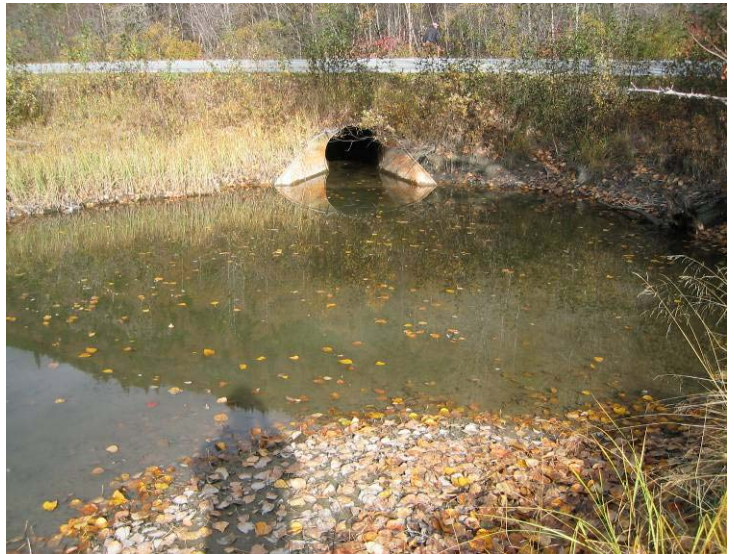
Description: Based on hand measurements, upstream of the culvert the stream is about 8' wide and flows over a silt/organic substrate. The stream is backwatered by the Chilkat River and had a depth of 6-8" at the time of the survey. Banks are muddy and grassy, with willow and alder growing close to the water on one side. The culvert empties into a 30' diameter pool with a depth of 3'. Banks are silty up to the level of frequent river backwater and then formed of grass and young willow/alder. Substrate is silt. Downstream of the pool the channel is 10' wide but terminates abruptly at a sandbar about 125' from the road. A small trickle flows over the sandbar and into an isolated pool. Fish access is dependent on the river water level.

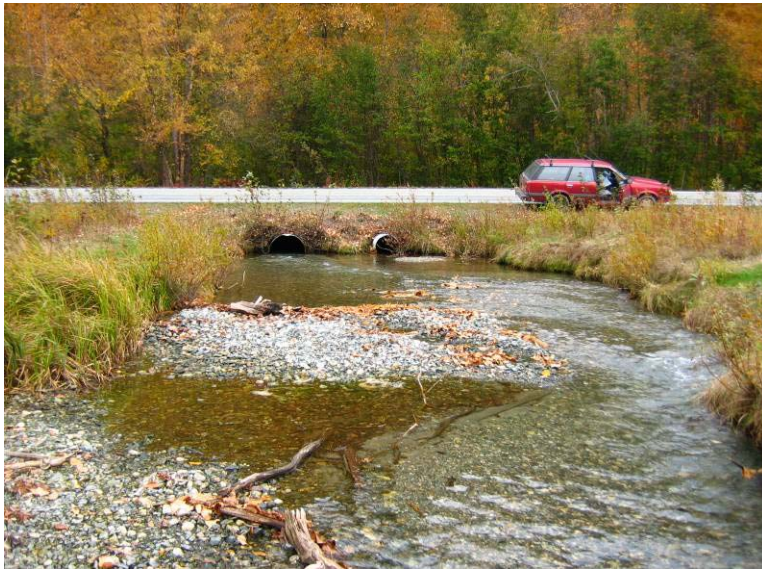
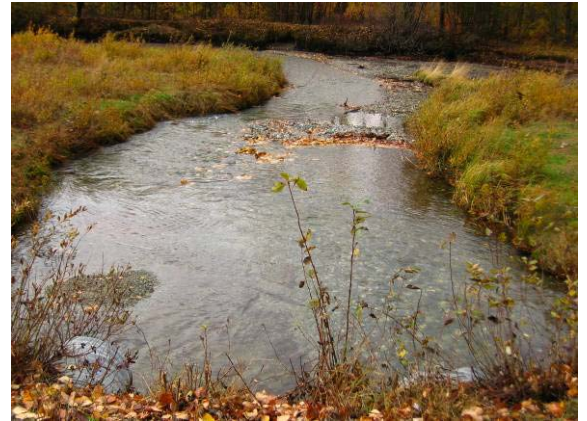
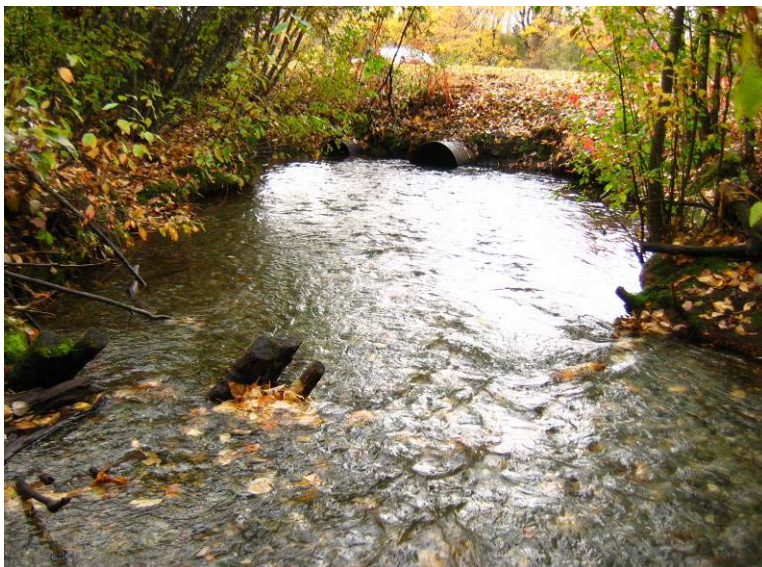
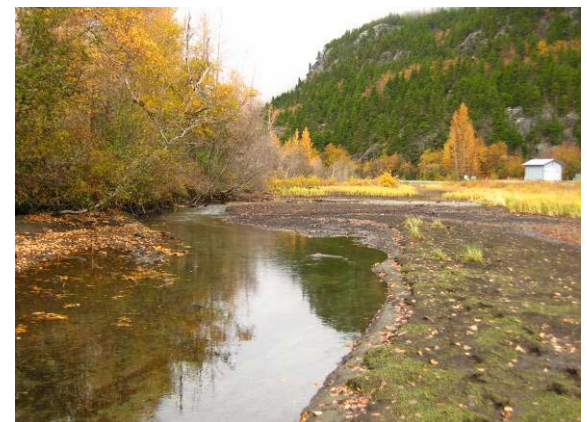
Description: Based on hand measurements, upstream of the culverts the stream is about 15' wide and flows in riffles over ideal spawning gravels. The banks are well vegetated and overhang the stream. A hydroelectric plant is upstream. Downstream of the culverts the stream varies in width from 15-20', the bottom is gravel and the stream is heavily utilized by spawning salmon. Stream banks are fully vegetated with grasses. Further downstream the stream meanders through a wide, old river channel that is frequently backwatered by the river.

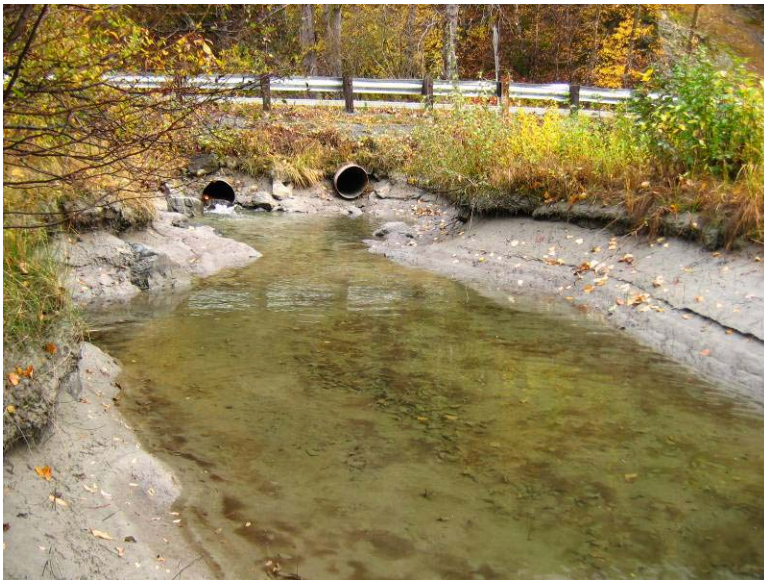
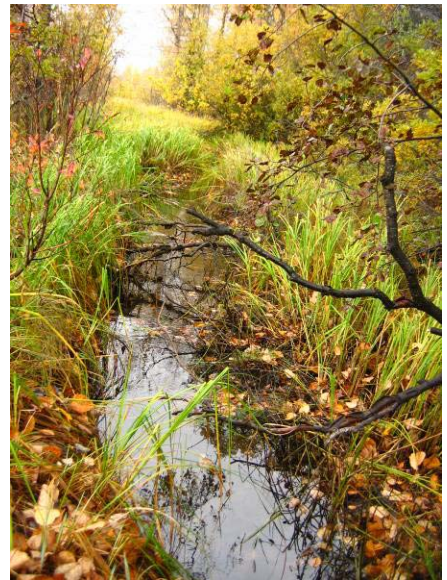
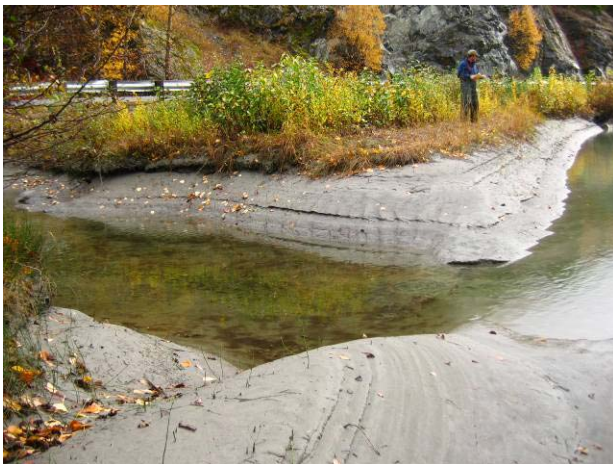
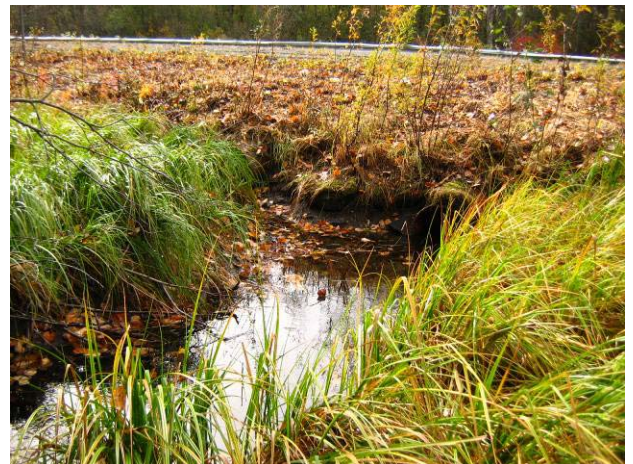
Description: Based on hand measurements, upstream of the culverts the stream is a 2' wide E type channel with a very low gradient. It is infrequently backwatered by the Chilkat River. The banks are thickly vegetated with grasses and the substrate is a blend of organics and silt. The stream leads into a broad swamp. Downstream of the culvert the stream banks are bare sand and the stream is heavily backwatered by the river. The substrate is silt/gravel and there is no cover.

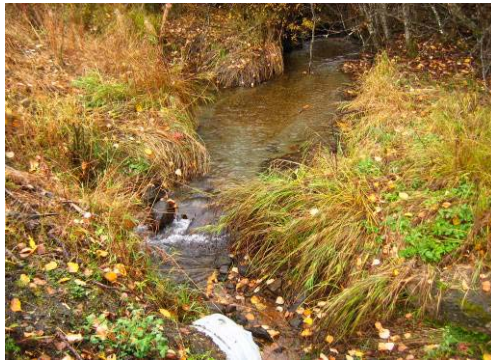
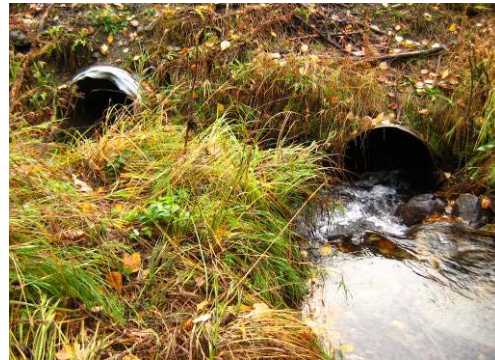
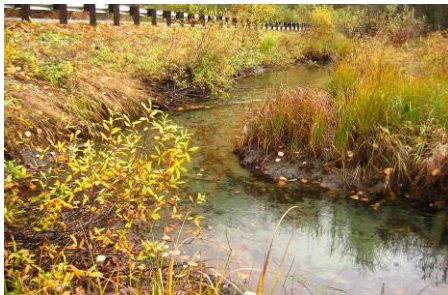
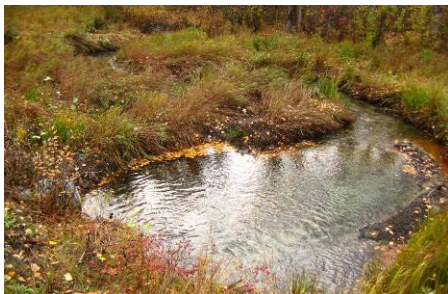
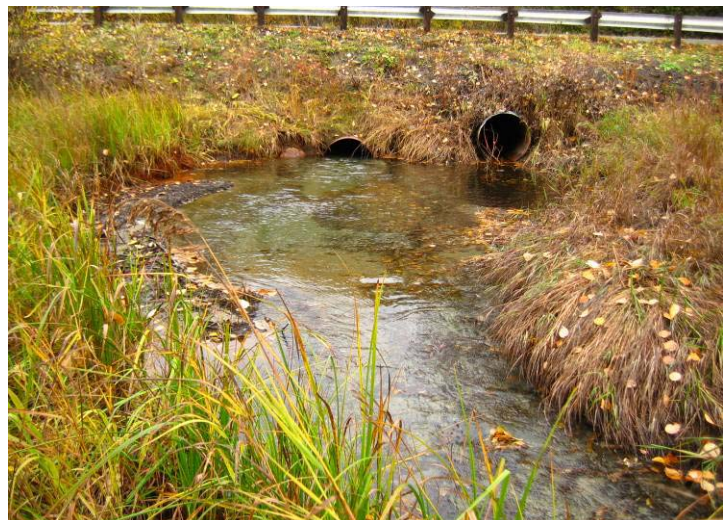
Description: Based on hand measurements, upstream of the culverts the stream splits almost immediately. The minor branch runs in a roadside ditch up to near station 675+00 where it turns away from the road. The section along the road is an E type channel 2' wide and +1' deep. The banks are vegetated with grasses that frequently overhang the full width of the stream. Substrate is gravel. Where it cuts away from the road, this section of the stream broadens and winds through established forest. The major branch of the stream is gravel bottomed and meanders away from the road in a stable bed with well forested banks. The culverts empty into a broad 15' by 20' pool that leads into a 4-8' wide E-channel backwatered at times by a beaver dam and the influence of a side channel of the river. The stream joins the river near station 664+25. The stream banks are predominantly grass, with some willow. At times, the stream flows directly along the toe of the road fill. The lower section of the stream is much less well vegetated than the upper portion.

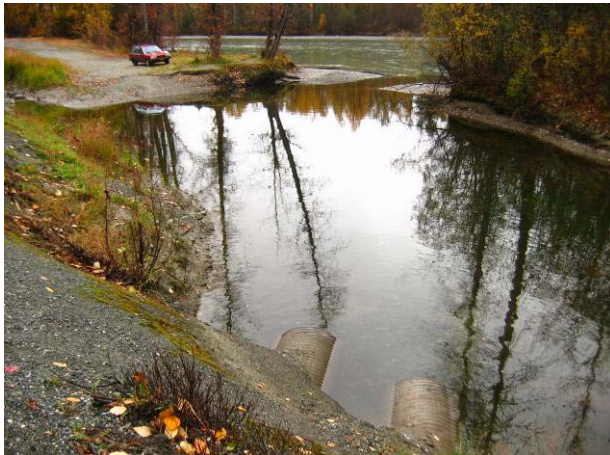
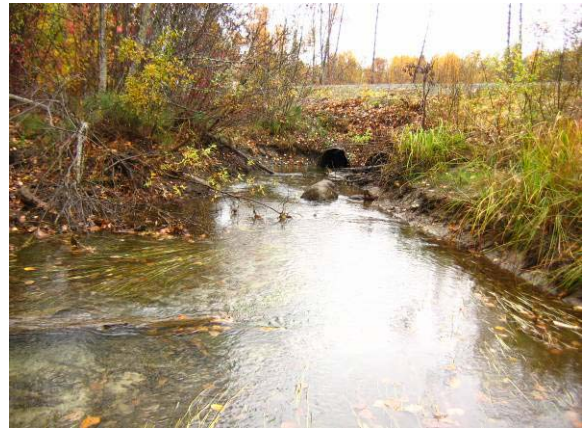
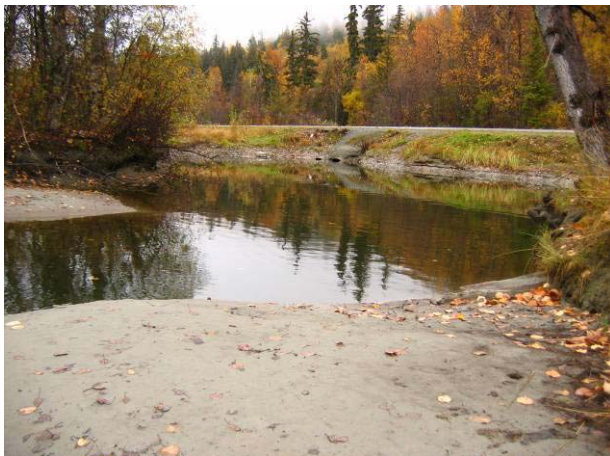
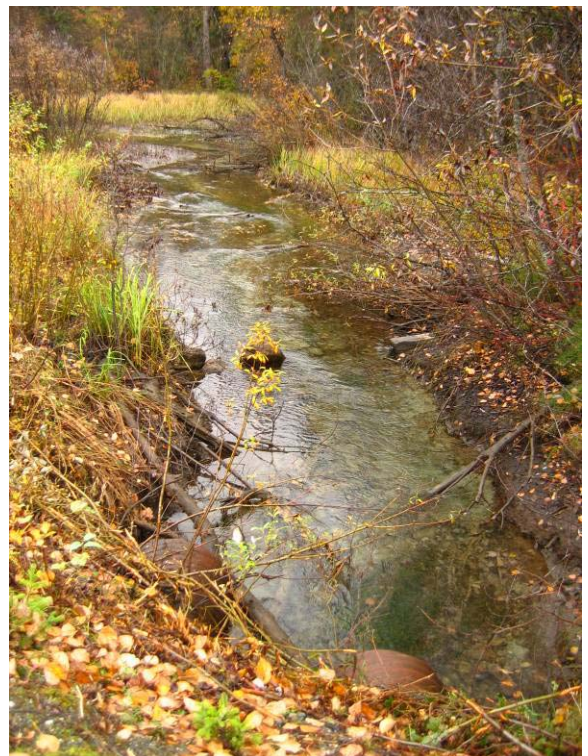
Description: Based on hand measurements, upstream of the culverts the stream is 8-10' wide and leads into a vegetated meadow. Stream banks are stable and vegetated with grasses and willow. The substrate is loose silt and organic matter. There is some backwatering by the river. The outlets of the culverts are nearly submerged even at low river levels and empty into a large, deep pool that acts as both a rearing area for fish and a boat launch site. The pool empties into the river via a short channel. There is some overhanging vegetation on one side of the pool. Substrate is sand and silt.

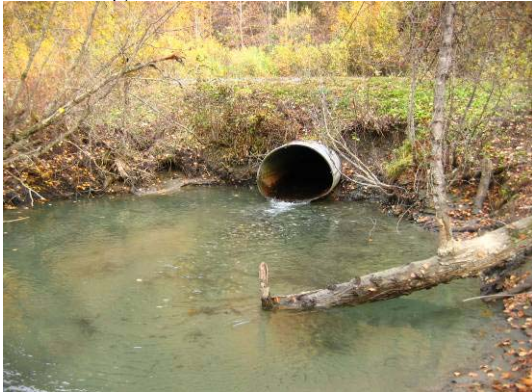
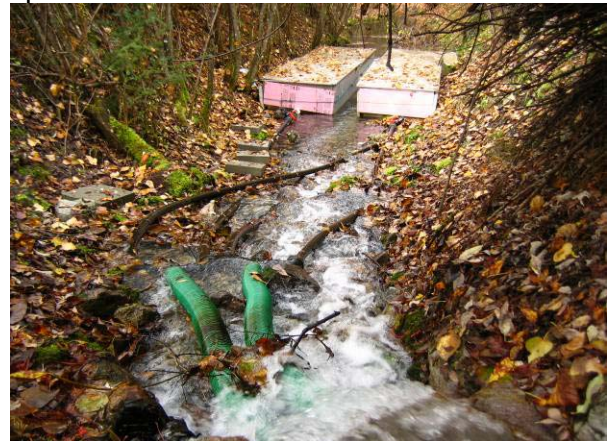
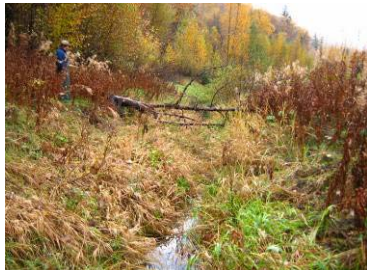
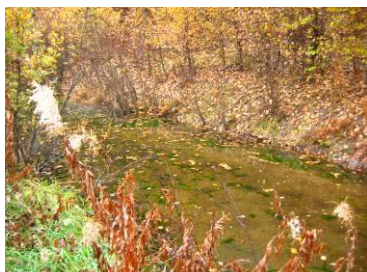
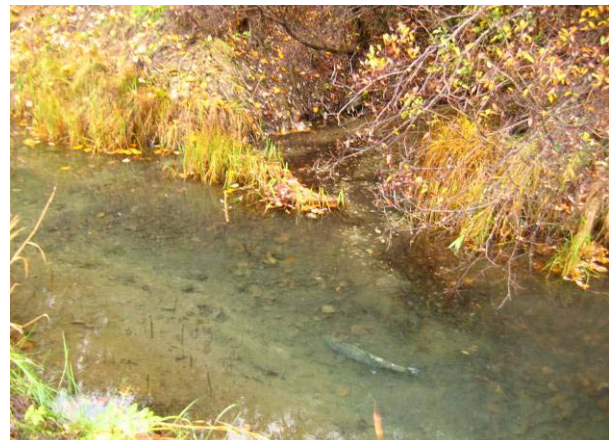
Description: The stream upstream of the culvert is a man-made complex consisting of two distinct branches. The main branch is a spring fed channel that runs up to station 895+00 where it ends in a beaver dam or man-made berm. Based on hand measurements, The lower half of this channel is consistently 8-10' wide and forms a slow moving pool 1-2' deep. The steep banks are vegetated with overhanging grasses. Several springs feed into the channel from under the bank on the mountain side. The upper half of the channel is a 2-3' wide riffle winding through boulders and thickly vegetated with grasses. The second branch of the complex feeds into the main branch about 100' upstream of the culvert inlet. This branch is fed by a series of springs, as well as a mountain stream, and rises in a series of pools and riffles up to a chum salmon incubation box facility operated by the Northern Southeast Regional Aquaculture Association. The stream substrate is gravel/cobble and the banks are well vegetated. Downstream the culvert outlet empties into a large pool used as a holding area for adult chum salmon. The pipe is perched 4". Pool substrate is silt covered gravel. A short channel connects the pool to the Chilkat River.

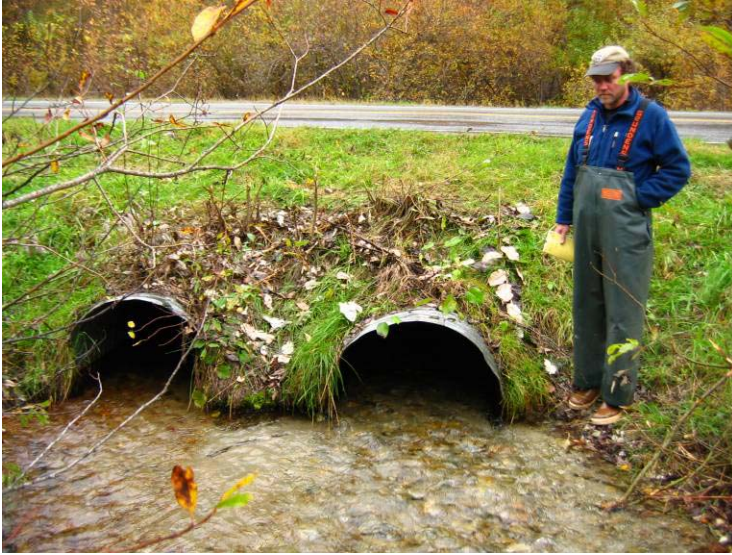
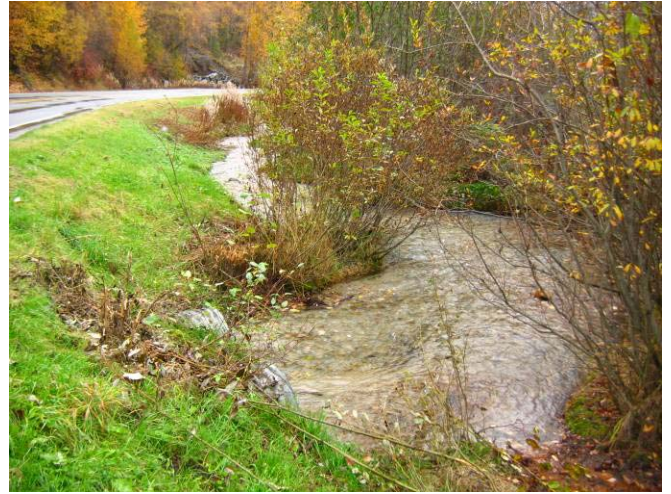
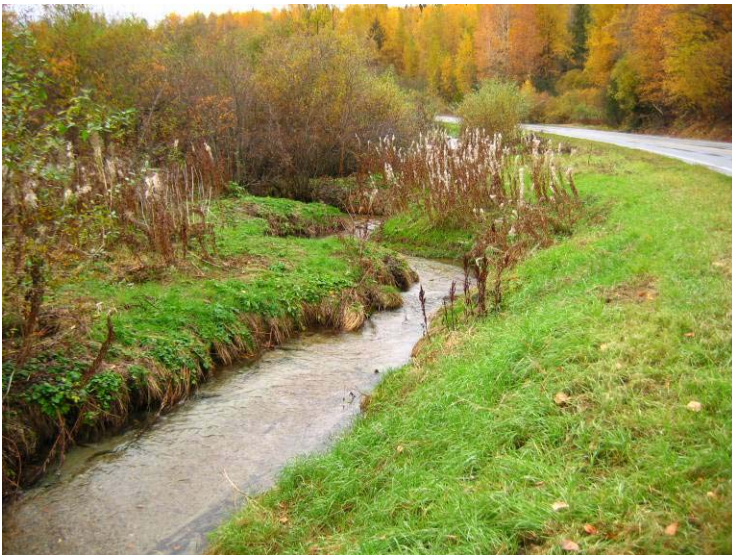
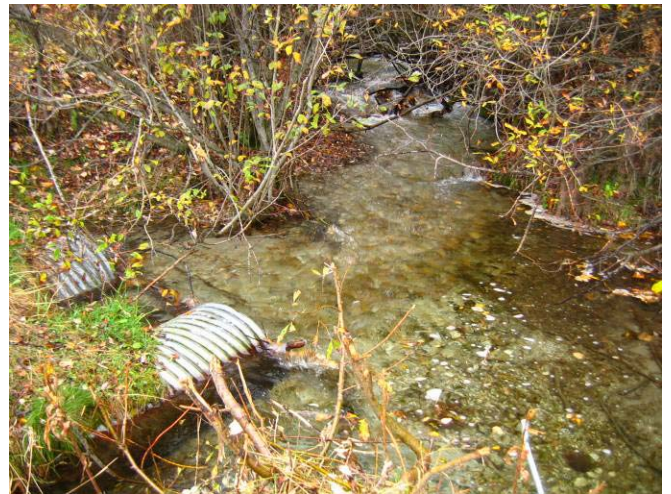
Station 917+00 – Existing conditions photos (cont'd)

The downstream reach connecting to the slough widens to a maximum width of 15' and is subject to backwatering when the Chilkat River is high. The stream substrate is silt, and the banks are steep and well vegetated. Two small streams draining the wetlands enter Horse Farm Creek from the west.

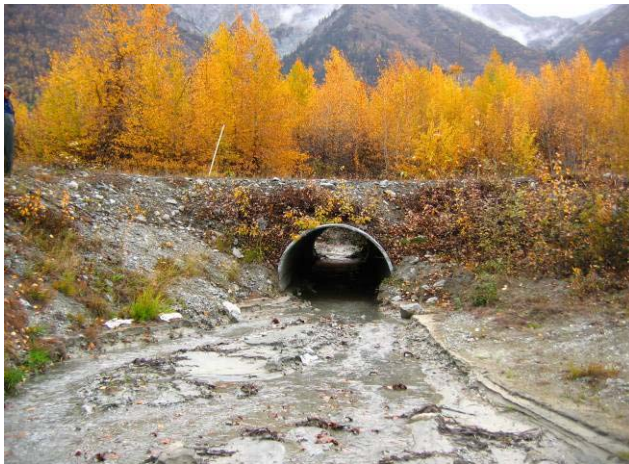
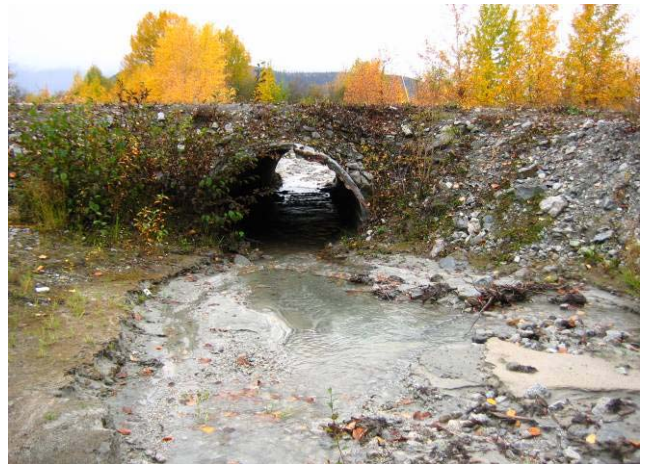
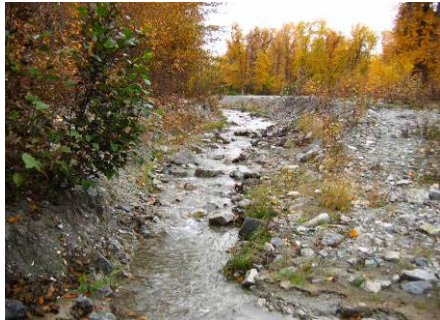
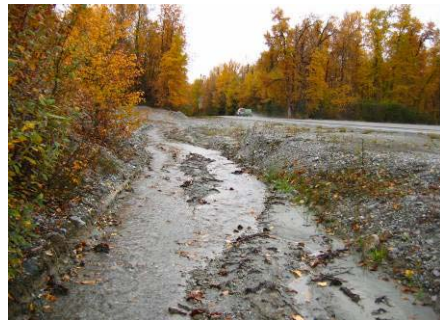
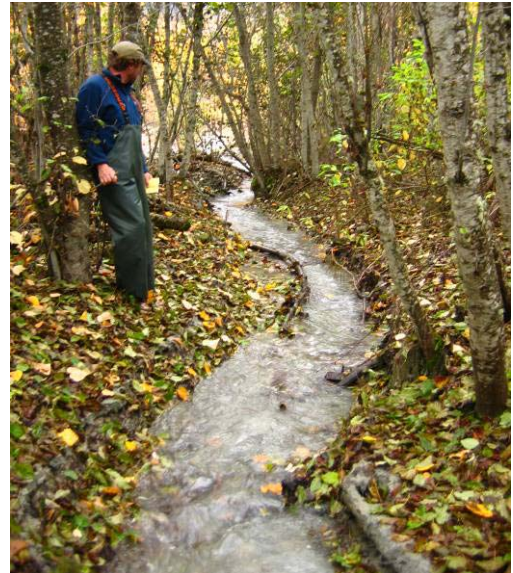
Description: This stream is part of the 19 mile slide area and is subject to alteration by the periodic influx and mechanical removal of large quantities of slide material. This material consists of fine decomposed rock and gravels mixed with cobbles. The stream above the culvert runs in an open ditch along the road back to station 979+00. No vegetation is present yet numerous juvenile fish were seen in the stream. The stream turns away from the road and runs toward the mountain for about 75' before any upstream movement of fish is prevented by a barrier falls. Downstream of the culvert the stream is braided and open until it intersects the woods several hundred feet below the pipe. The substrate is slide material and initially there is little vegetation. Once the stream enters the woods it is a 2-3' wide fast riffle until it empties into a series of riverside pools fed by upwelling water.

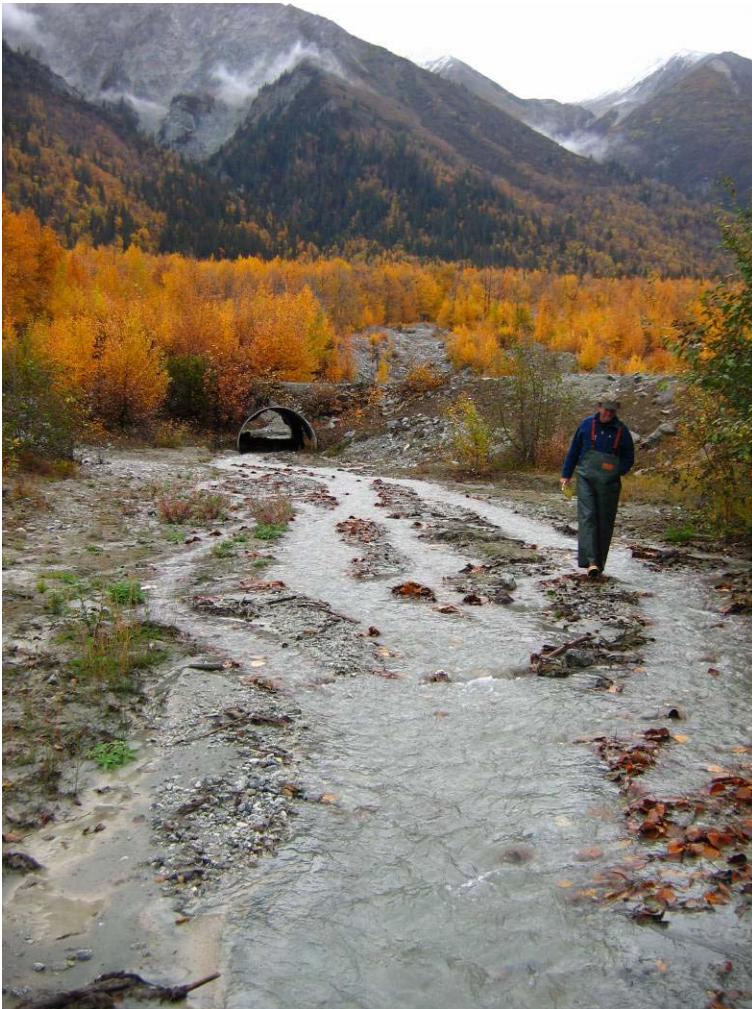
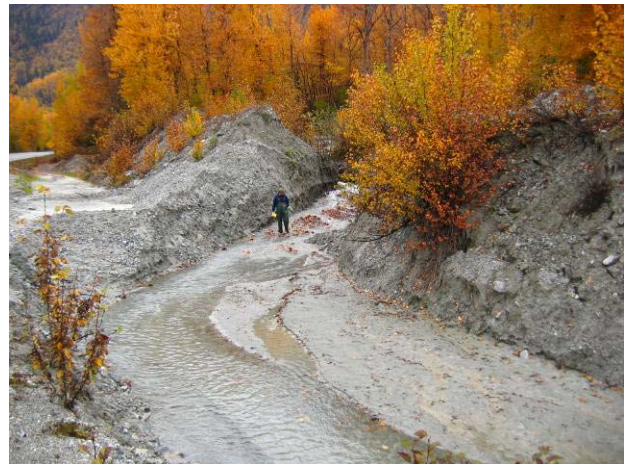
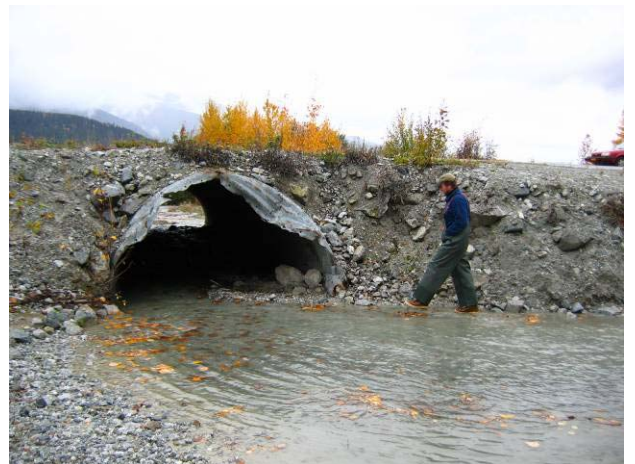
Description: The stream above the culvert of this 19 mile slide stream is very unstable and often excavated by heavy equipment. Substrate is mobile slide material. Some vegetation is beginning to be established on the banks. Fish passage above the culvert is blocked by a headcut upstream 200'. Downstream of the culvert the stream is initially a braided riffle with little sign of viable fish habitat. Two hundred feet downstream of the culvert outlet the stream becomes a steep cascade through boulders until it enters the river.

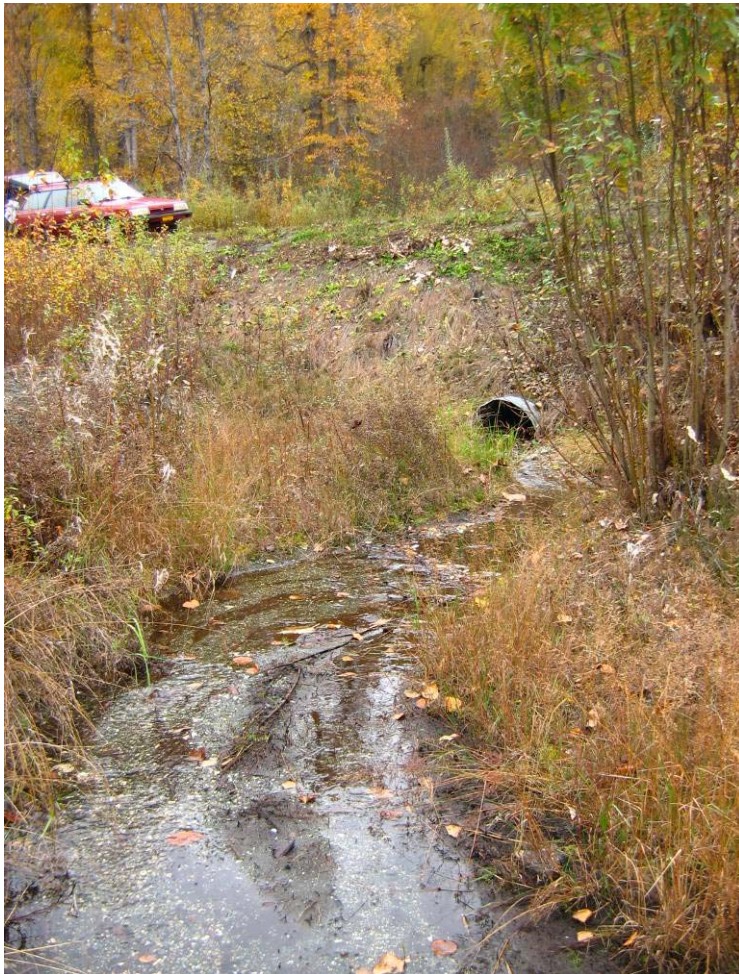
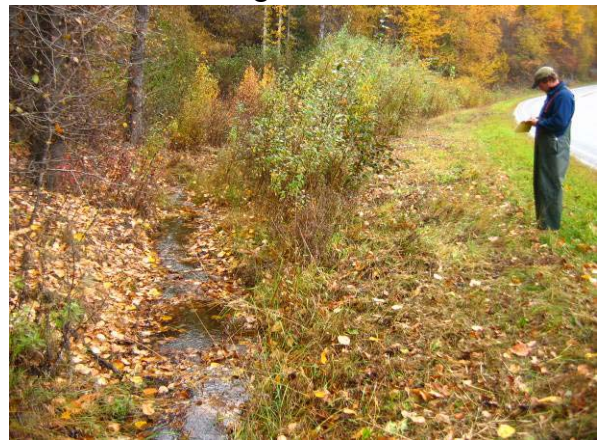
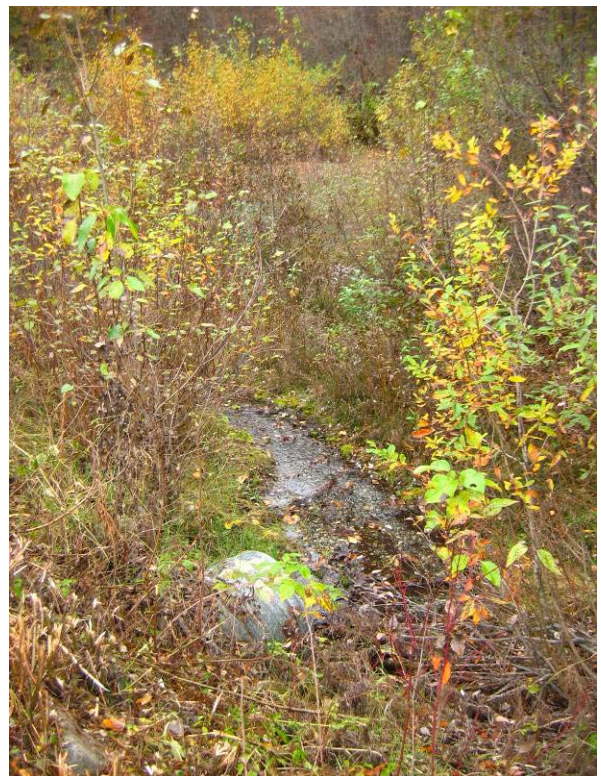
Description: Based on hand measurements, upstream of the culverts the stream is 1-2' wide and composed of riffle habitat. The stream runs alongside the road up to station 1134+00 before the channel turns away from the road. For the first 150' above the culvert the stream lies away from the toe of the road fill slope and cover is provided by adjacent willow and alder. The stream then runs tight along the toe and the banks are vegetated with grasses. Downstream of the culvert the stream flows through a manipulated habitat with patches of willow and grasses beginning to be established. For both portions of the stream the substrate is small gravel.

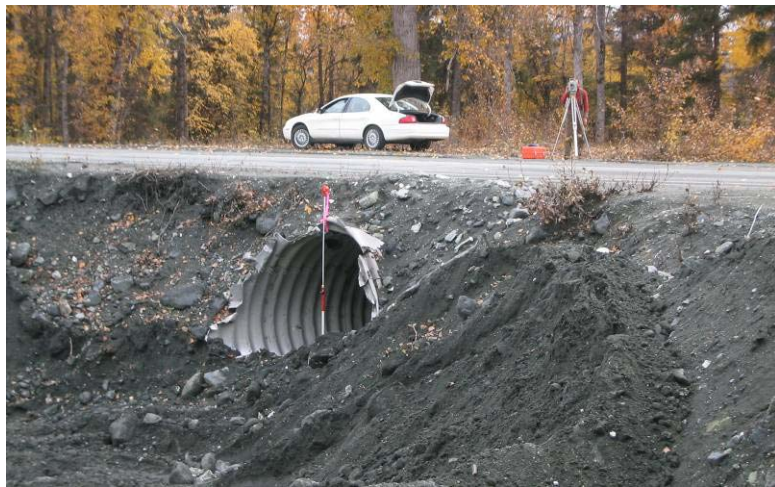
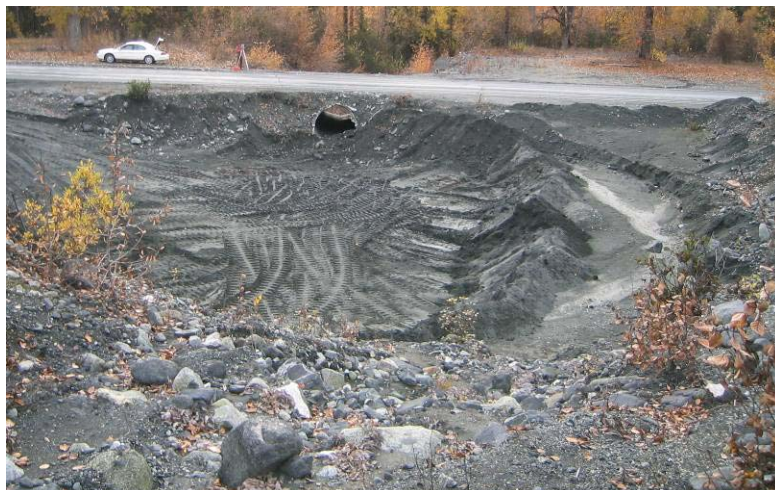
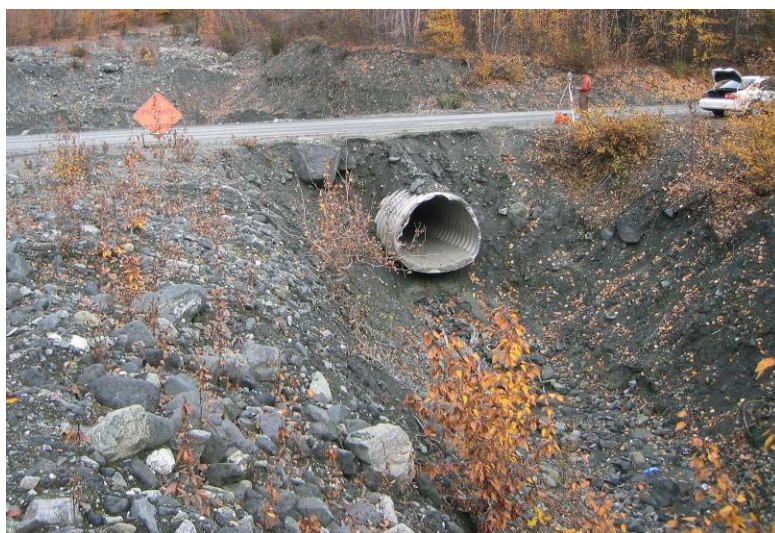
19.8 Station 1208+20 – Existing conditions photos

Existing Culvert: 8'-2" x 5'-9" pipe arch
